Volcano Cymbidium Acres Road Maintenance Corp. 2024 Pavement Surface Evaluation and Rating

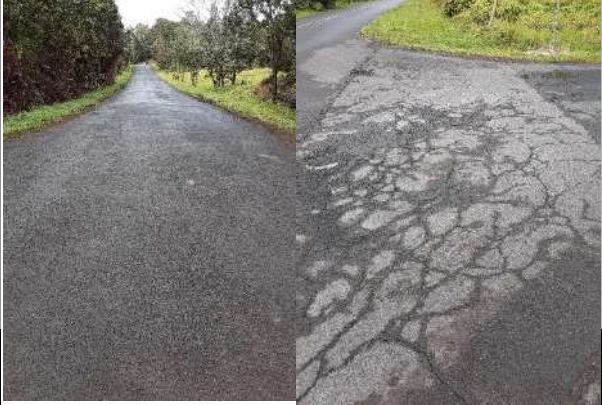
ROAD A – Olomea Road (Section 1)	
From Wright Rd to c/l Ke Koa Nui Blvd	Photos
5.4 TOTAL RATING

Surface Defects: Raveling: Slight X Moderate Severe	
Surface Deformation: Rutting: Slight Distortion: None	
Cracks: X Transverse Reflection Slippage X Longitudinal X Block Alligator	
Patches Potholes: X Small Large Multiple	
Notes: 40' ROW; 16' wide x 442' long Some edge deterioration; some small potholes forming near Ke Koa Nui

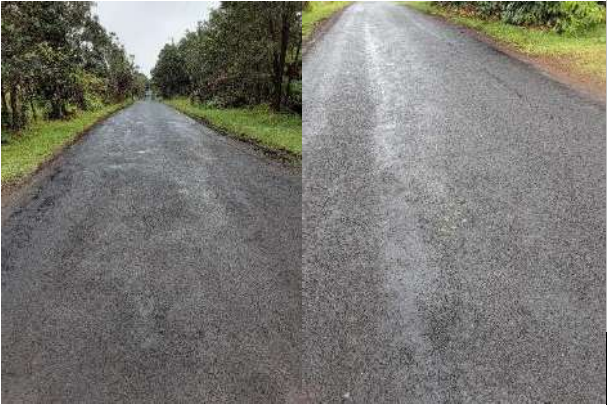
ROAD A - Olomea Road (Section 2)	
From c/l Ke Koa Nui Blvd to c/l Liko Lehua Rd	Photos
6 TOTAL RATING

Surface Defects: Raveling: Slight X Moderate Severe	
Surface Deformation: Rutting: Slight Distortion: None	
Cracks: Transverse Reflection Slippage Longitudinal Block Alligator	
Patches Potholes: X Small Large Multiple	
Notes: 40' ROW; 16' wide x 462' long No cracks evident; 1 pothole forming midway; some edge deterioration

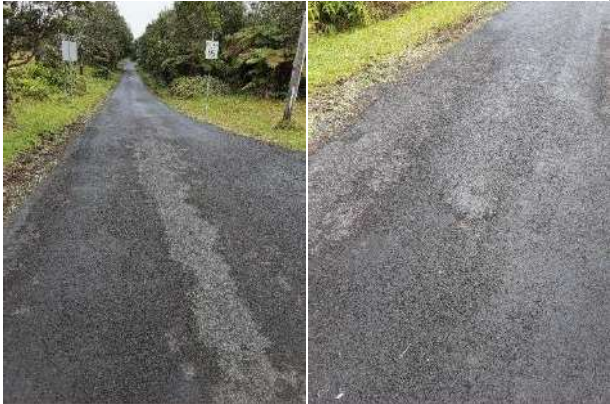
ROAD A - Olomea Road (Section 3)	
From c/l Liko Lehua Rd to c/l Kalaninauli Rd	Photos
5.8 TOTAL RATING

Surface Defects: Raveling: Slight X Moderate Severe	
Surface Deformation: Rutting: Slight Distortion: None	
Cracks: Transverse Reflection Slippage Longitudinal Block Alligator	
Patches Potholes: X Small Large Multiple	
Notes: 40' ROW; 14' wide x 521' long Veg narrowed road; no cracking or patches Noted; some edge deterioration

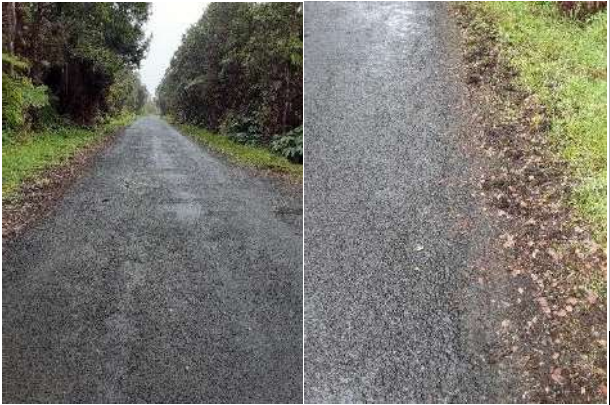
ROAD A - Olomea Road (Section 4)	
From c/l Kalaninauli Rd to end Kawailehua Rd	Photos
5.4 TOTAL RATING

Surface Defects: Raveling: Slight X Moderate Severe	
Surface Deformation: Rutting: Slight Distortion: None	
Cracks: Transverse Reflection Slippage Longitudinal Block Alligator	
Patches Potholes: X Small Large Multiple	
Notes: 40' ROW; 14' wide x 440' long Veg narrowed road; no cracking noted; small potholes near Kawailehua; edge deterioration

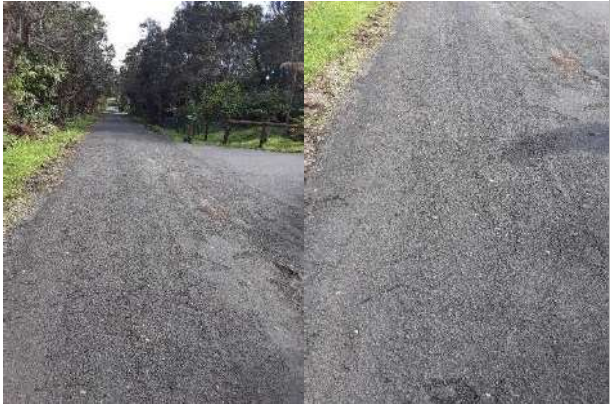
ROAD B – Ke Koa Nui Blvd (Section 1)	
From Olomea Rd to end 19-4251	Photos
2.6 TOTAL RATING

Surface Defects: Raveling: Slight X Moderate X Severe	
Surface Deformation: Rutting: Slight Distortion:	
Cracks: Transverse Reflection Slippage X Longitudinal Block X Alligator	
Patches Potholes: X Small Large X Multiple	
Notes: 40' ROW; 10'-14' wide x 524' long Veg narrowed road; edge deterioration; much cracking; many potholes; trees in ROW

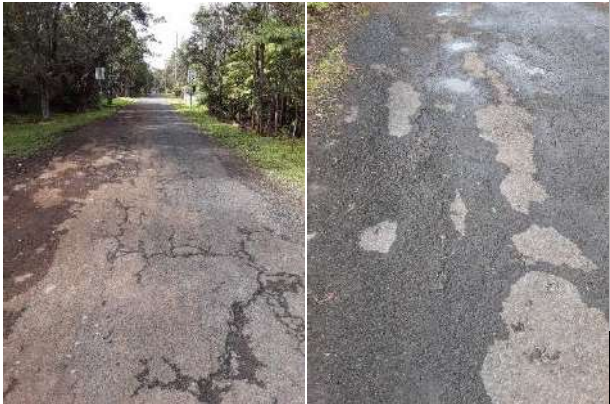
ROAD B – Ke Koa Nui Blvd (Section 2)	
From end 19-4251 to begin 19-4225	Photos
3.0 TOTAL RATING

Surface Defects: Raveling: Slight X Moderate Severe	
Surface Deformation: Rutting: slight Distortion: None	
Cracks: Transverse Reflection Slippage X Longitudinal Block X Alligator	
Patches Potholes: X Small Large Multiple	
Notes: 40' ROW; 11'-9" – 14' wide x 516' long Veg narrowed road; edge deterioration; some cracking noted; small potholes forming

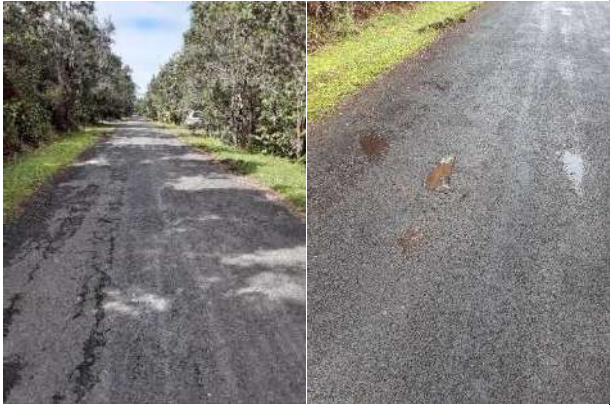
ROAD B – Ke Koa Nui Blvd (Section 3)	
From begin 19-4225 to begin 19-4205	Photos
3.4 TOTAL RATING

Surface Defects: Raveling: X Slight X Moderate Severe	
Surface Deformation: Rutting: Slight Distortion: None	
Cracks: Transverse Reflection Slippage X Longitudinal Block X Alligator	
Patches Potholes: X Small Large X Multiple	
Notes: 40' ROW; 13' - 16' wide x 516' long Veg narrowed road; edge deterioration; much cracking, potholes; 50' rough section

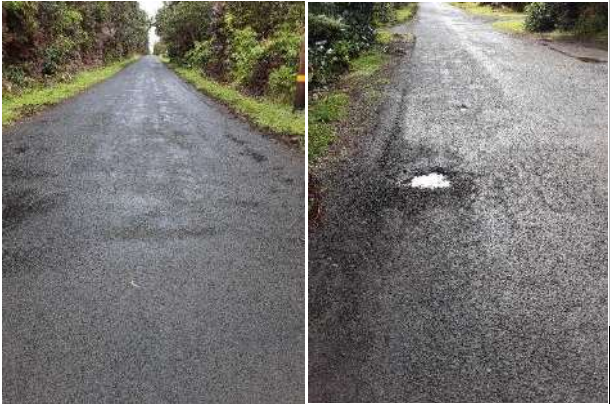
ROAD B – Ke Koa Nui Blvd (Section 5)	
From end 19-4187 to Laukapu Rd	Photos
3.8 TOTAL RATING

Surface Defects: Raveling: X Slight X Moderate Severe	
Surface Deformation: Rutting: Slight Distortion: None	
Cracks: Transverse Reflection Slippage X Longitudinal Block X Alligator	
Patches Potholes: X Small Large X Multiple	
Notes: 40' ROW; 15' – 18' wide x 423' long Some veg narrowing road; 40' long bad section with cracking and potholes

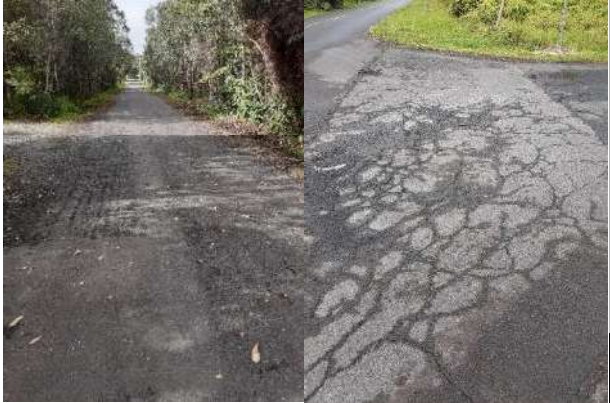
ROAD C – Liko Lehua Rd (Section 1)	
From Olomea Rd to begin 19-4245	Photos
2.8 TOTAL RATING

Surface Defects: Raveling: Slight X Moderate X Severe	
Surface Deformation: Rutting: Slight Distortion: None	
Cracks: X Transverse Reflection Slippage X Longitudinal Block X Alligator	
Patches Potholes: X Small Large X Multiple	
Notes: 40' ROW; 13' wide x 524' long Veg narrowed road; edge deterioration; much cracking and small potholes

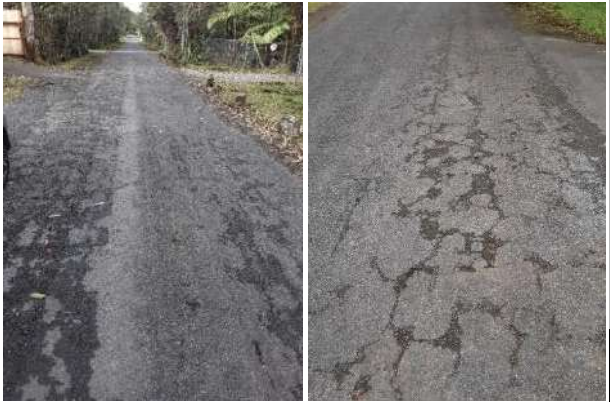
ROAD C – Liko Lehua Rd (Section 2)	
From begin 19-4245 to end 19-4229	Photos
3.2 TOTAL RATING

Surface Defects: Raveling: Slight X Moderate X Severe	
Surface Deformation: Rutting: Slight Distortion: None	
Cracks: X Transverse Reflection Slippage X Longitudinal Block X Alligator	
Patches Potholes: X Small Large X Multiple	
Notes: 40' ROW; 15' wide x 516' long; Veg narrowed road; edge deterioration; much cracking and potholes; 100' bad section; root damage

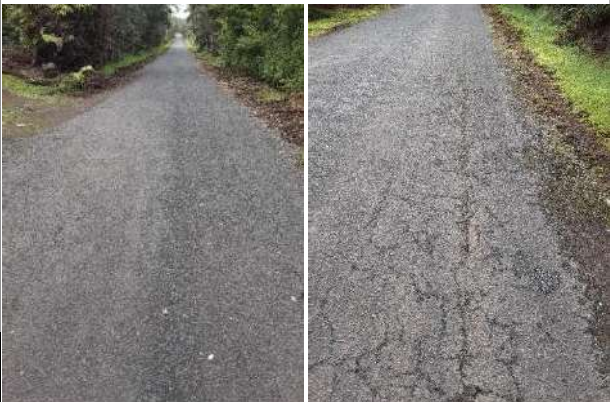
ROAD C – Liko Lehua Rd (Section 3)	
From end 19-4229 to end Lots 75/112	Photos
5.4 TOTAL RATING

Surface Defects: Raveling: X Slight X Moderate Severe	
Surface Deformation: Rutting: Slight Distortion: None	
Cracks: Transverse Reflection Slippage X Longitudinal Block X Alligator	
Patches Potholes: Small Large Multiple	
Notes: 40' ROW; 14' wide x 516' long Veg narrowed road; some cracking noted; no potholes noted

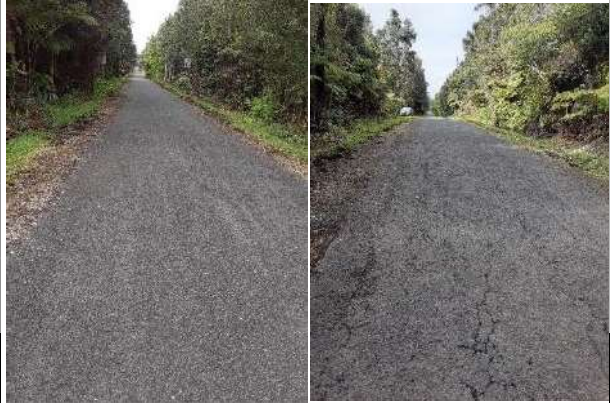
ROAD C – Liko Lehua Rd (Section 4)	
From end Lots 75/112 to begin 19-4183	Photos
3.6 TOTAL RATING

Surface Defects: Raveling: Slight X Moderate X Severe	
Surface Deformation: Rutting: Slight Distortion: None	
Cracks: X Transverse Reflection Slippage X Longitudinal X Block X Alligator	
Patches Potholes: Small Large Multiple	
Notes: 40' ROW; 14' wide x 516' long; Veg narrowed road; some edge deterioration; 100' very bad section; much cracking and potholes noted

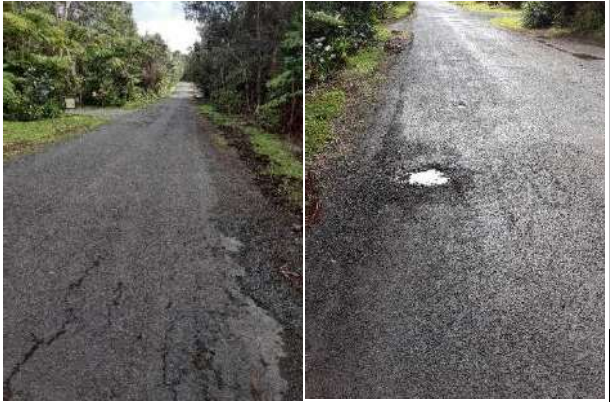
ROAD C – Liko Lehua Rd (Section 5)	
From begin 19-4183 to Laukapu Rd	Photos
4.2 TOTAL RATING

Surface Defects: Raveling: X Slight X Moderate Severe	
Surface Deformation: Rutting: Slight Distortion: None	
Cracks: X Transverse Reflection Slippage Longitudinal X Block X Alligator	
Patches Potholes: Small Large Multiple	
Notes: 40' ROW; 15' wide x 423' long Veg narrowed road; some edge deterioration; some cracking and potholes noted

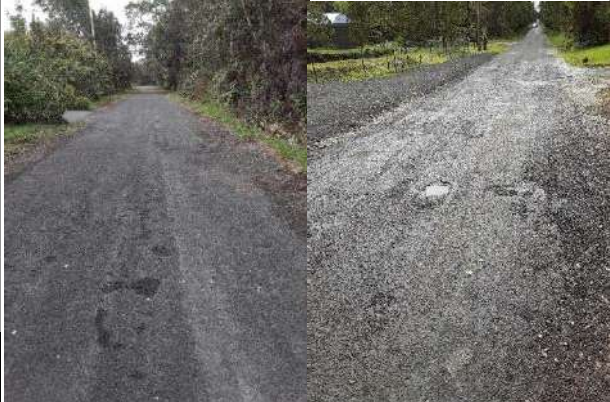
ROAD D – Kalaninauli Rd (Section 1)	
From Olomea Rd to end 19-4249	Photos
5.6 TOTAL RATING

Surface Defects: Raveling: X Slight X Moderate Severe	
Surface Deformation: Rutting: Slight Distortion: None	
Cracks: Transverse Reflection Slippage Longitudinal Block X Alligator	
Patches Potholes: X Small Large Multiple	
Notes: 50' ROW; 16' wide x 524' long Some edge deterioration and minor cracking noted; some small potholes forming

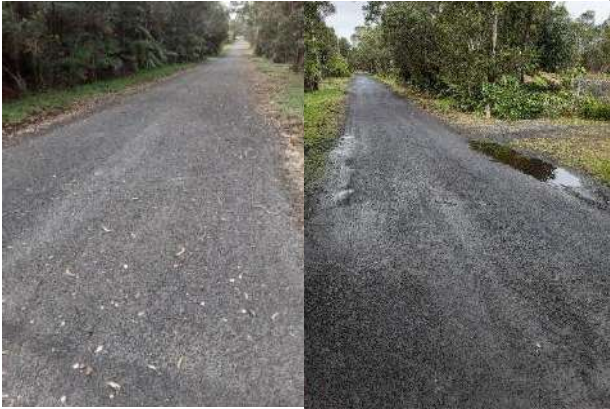
ROAD D – Kalaninauli Rd (Section 2)	
From end 19-4249 to center 19-4223	Photos
6.2 TOTAL RATING

Surface Defects: Raveling: X Slight Moderate Severe	
Surface Deformation: Rutting: Slight Distortion: None	
Cracks: Transverse Reflection Slippage Longitudinal X Block X Alligator	
Patches Potholes: Small Large Multiple	
Notes: 50' ROW; 12' - 16' wide x 516' long Veg narrowed road; some edge deterioration; some cracking noted; low spot worst section

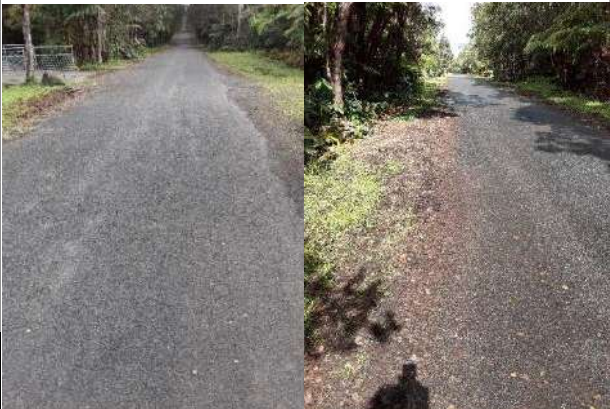
ROAD D – Kalaninauli Rd (Section 3)	
From center 19-4223 to end Lot 113	Photos
6.8 TOTAL RATING

Surface Defects: Raveling: X Slight Moderate Severe	
Surface Deformation: Rutting: Slight Distortion: None	
Cracks: Transverse Reflection Slippage Longitudinal Block X Alligator	
Patches Potholes: Small Large Multiple	
Notes: 50' ROW; 13' - 15' wide x 516' long Veg narrowed road; edge deterioration; minor cracking beginning; no potholes noted

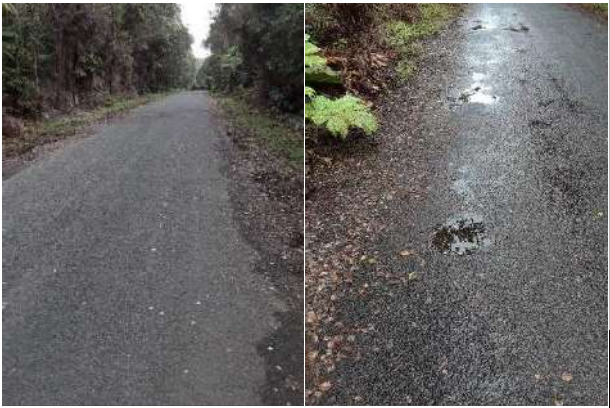
ROAD D – Kalaninauli Rd (Section 4)	
From end Lot 113 to end 19-4187	Photos
6.6 TOTAL RATING

Surface Defects: Raveling: X Slight Moderate Severe	
Surface Deformation: Rutting: Slight Distortion: None	
Cracks: Transverse Reflection Slippage Longitudinal Block X Alligator	
Patches Potholes: X Small Large Multiple	
Notes: 50' ROW; 16' wide x 516' long Edge deterioration starting; some minor cracking noted

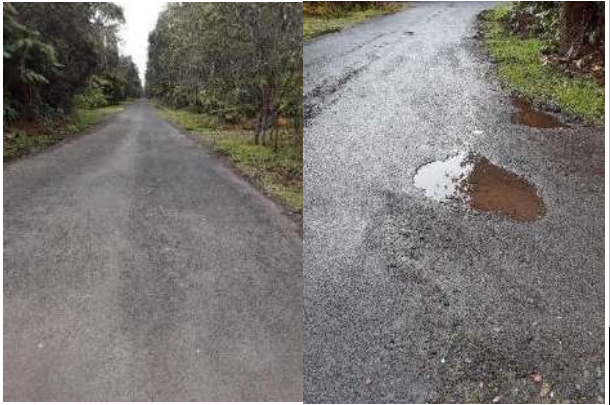
ROAD D – Kalaninauli Rd (Section 5)	
From end 19-4187 to Laukapu Rd	Photos
6.6 TOTAL RATING

Surface Defects: Raveling: X Slight Moderate Severe	
Surface Deformation: Rutting: Slight Distortion: None	
Cracks: Transverse Reflection Slippage Longitudinal Block X Alligator	
Patches Potholes: X Small Large Multiple	
Notes: 50' ROW; 16' wide x 423' long Some minor cracking and small potholes starting (at one particular driveway)

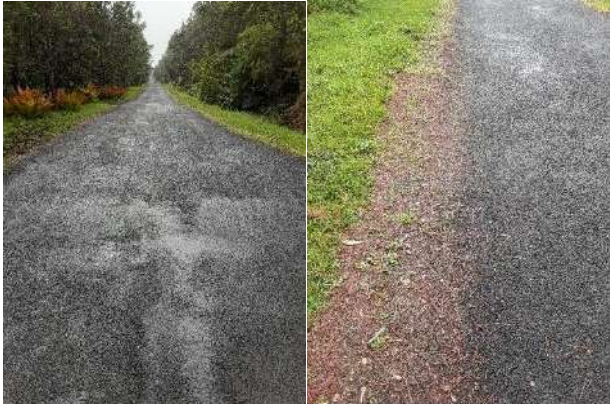
ROAD E – Kawailehua Rd (Section 1)	
From Olomea Rd to center 19-4247	Photos
5 TOTAL RATING

Surface Defects: Raveling: Slight X Moderate Severe	
Surface Deformation: Rutting: Slight Distortion: None	
Cracks: Transverse Reflection Slippage Longitudinal Block Alligator	
Patches Potholes: Small Large Multiple	
Notes: 40' ROW; 11' - 16' wide x 524' long Veg narrowed road; new trees planted in ROW; no cracks or potholes noted

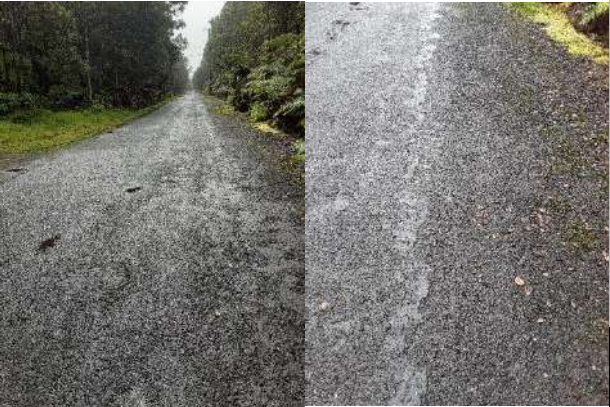
ROAD E – Kawailehua Rd (Section 3)	
From end 19-4231 to center 19-4207	Photos
3.2 TOTAL RATING

Surface Defects:	
Raveling: Slight Moderate X Severe	
Surface Deformation:	
Rutting: Slight Distortion: None	
Cracks: Transverse Reflection Slippage Longitudinal Block X Alligator	
Patches	
Potholes: X Small Large X Multiple	
Notes: 40' ROW; 13' wide x 516' long Veg narrowed road; some cracking forming; small potholes forming; edge deterioration

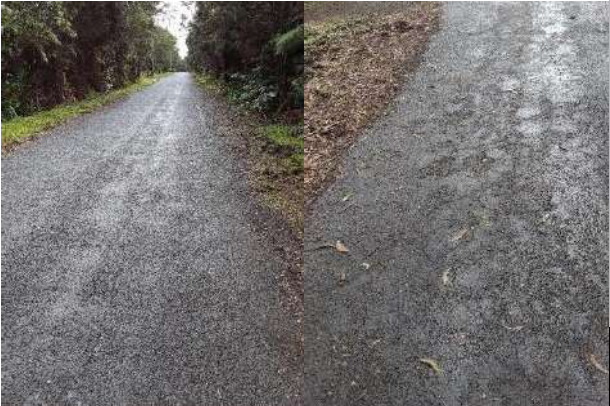
ROAD E – Kawailehua Rd (Section 4)	
From center 19-4207 to begin 19-4183	Photos
3.6 TOTAL RATING

Surface Defects:	
Raveling: Slight Moderate X Severe	
Surface Deformation:	
Rutting: Slight Distortion: None	
Cracks: Transverse Reflection Slippage Longitudinal Block X Alligator	
Patches	
Potholes: X Small Large X Multiple	
Notes: 40' ROW; 16' wide x 516' long Some edge deterioration; some cracking forming; numerous small potholes forming

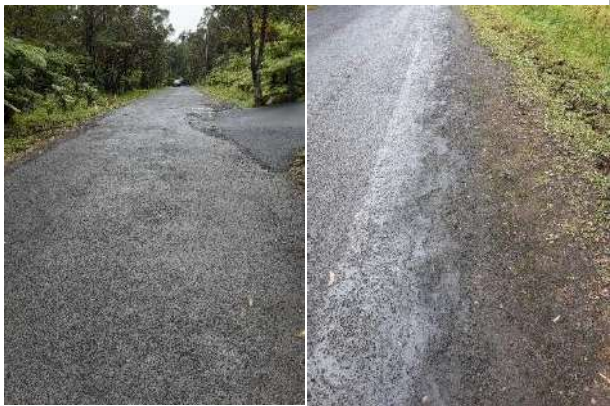
ROAD E – Kawailehua Rd (Section 5)	
From begin 19-4183 to Laukapu Rd	Photos
4.4 TOTAL RATING

Surface Defects:	
Raveling: Slight X Moderate X Severe	
Surface Deformation:	
Rutting: Slight Distortion: None	
Cracks: Transverse Reflection Slippage Longitudinal X Block X Alligator	
Patches	
Potholes: X Small Large X Multiple	
Notes: 40' ROW; 15' wide x 423' long Veg narrowed road; some edge deterioration; cracking and potholes forming

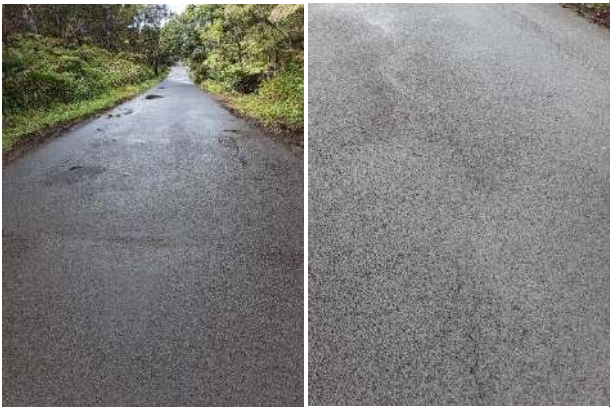
RIL – Laukapu Rd (Section 1)	
From Wright Rd to c/l Ke Koa Nui Blvd	Photos
6.2 TOTAL RATING

Surface Defects: Raveling: X Slight Moderate Severe	
Surface Deformation: Rutting: Slight Distortion: None	
Cracks: Transverse Reflection Slippage Longitudinal X Block X Alligator	
Patches Potholes: X Small Large X Multiple	
Notes: ? ROW; 16' wide x 442' long Numerous minor cracking and potholes forming

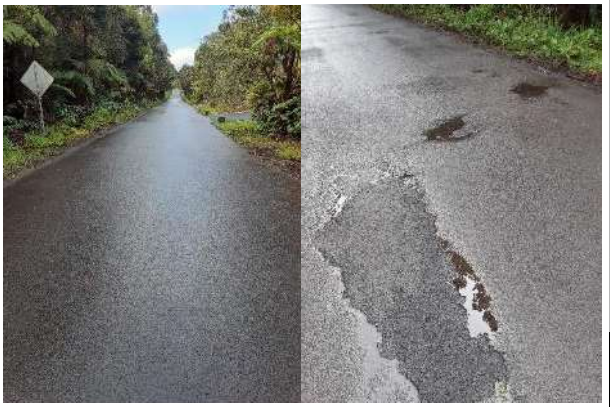
RIL – Laukapu Rd (Section 2)	
From c/l Ke Koa Nui Blvd to c/l Liko Lehua Rd	Photos
6.6 TOTAL RATING

Surface Defects: Raveling: X Slight Moderate Severe	
Surface Deformation: None Rutting: Distortion: None	
Cracks: X Transverse Reflection Slippage X Longitudinal Block X Alligator	
Patches Potholes: X Small Large X Multiple	
Notes: ? ROW; 17' wide x 462' long Numerous cracking and potholes forming, especially at Ke Koa Nui

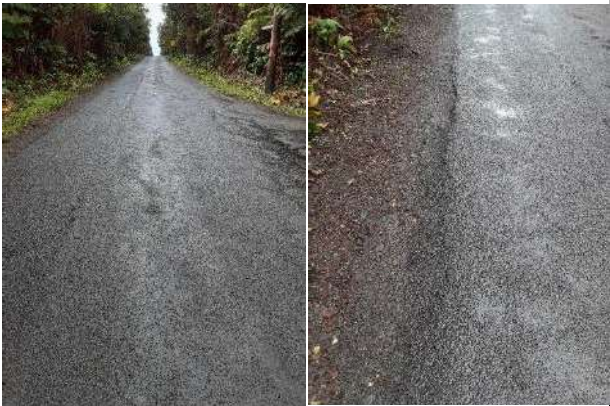
RIL – Laukapu Rd (Section 3)	
From c/l Liko Lehua Rd to c/l Kalaninauli Rd	Photos
6.2 TOTAL RATING

Surface Defects: Raveling: X Slight Moderate Severe	
Surface Deformation: Rutting: Slight Distortion: None	
Cracks: Transverse Reflection Slippage Longitudinal Block Alligator	
Patches Potholes: Small Large Multiple	
Notes: ? ROW; 16' wide x 521' long No cracking or potholes noted
